November 15, 1962

## REPORT OF TEST [ ] ACTIVITIES - NON-VACUUM WINDOW

22 OCT. 62 - 5 NOV. 62

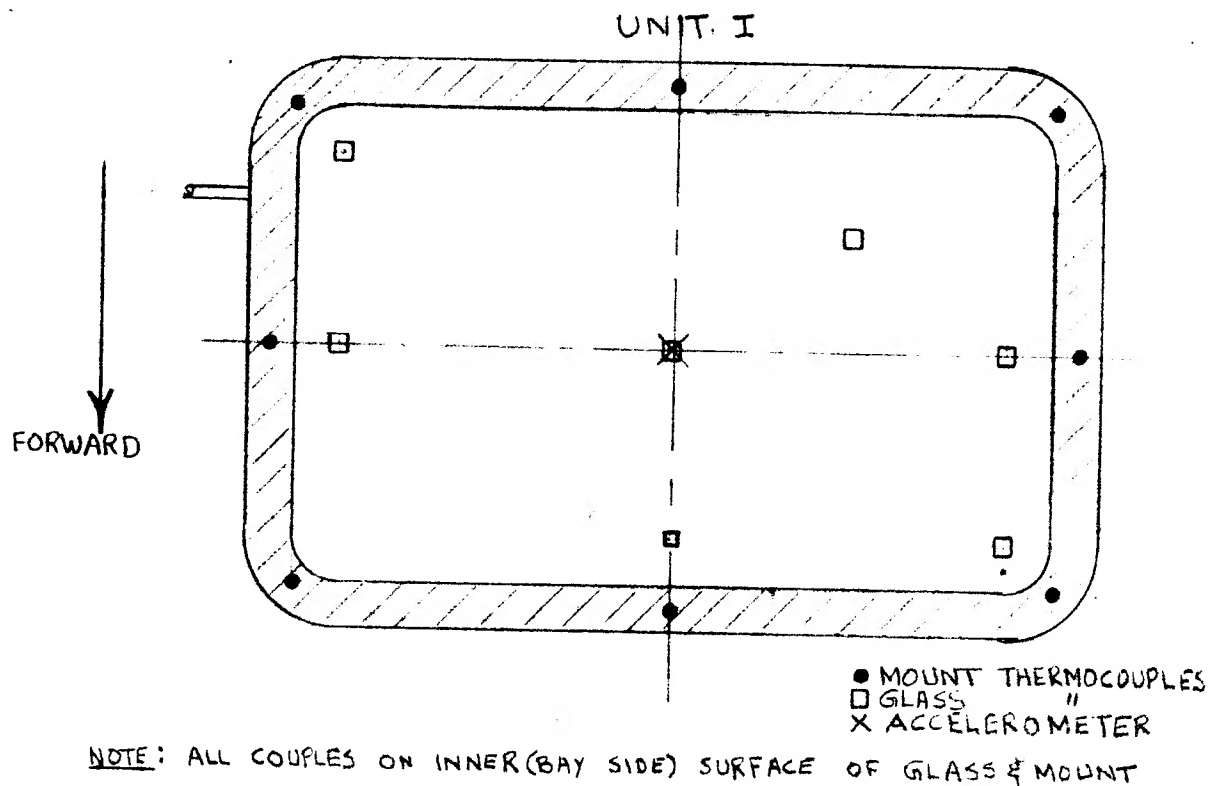
# THERMOCOUPLE LOCATION

Unit No. 1 was instrumented as shown in Figure 1. In addition to the

thermocouples shown, additional thermocouples were placed:

1. Between skin and mount in right forward corner of unit #1
2. On inner surface of skin at center of hatch
3. In center of bay approximately 6" above skin

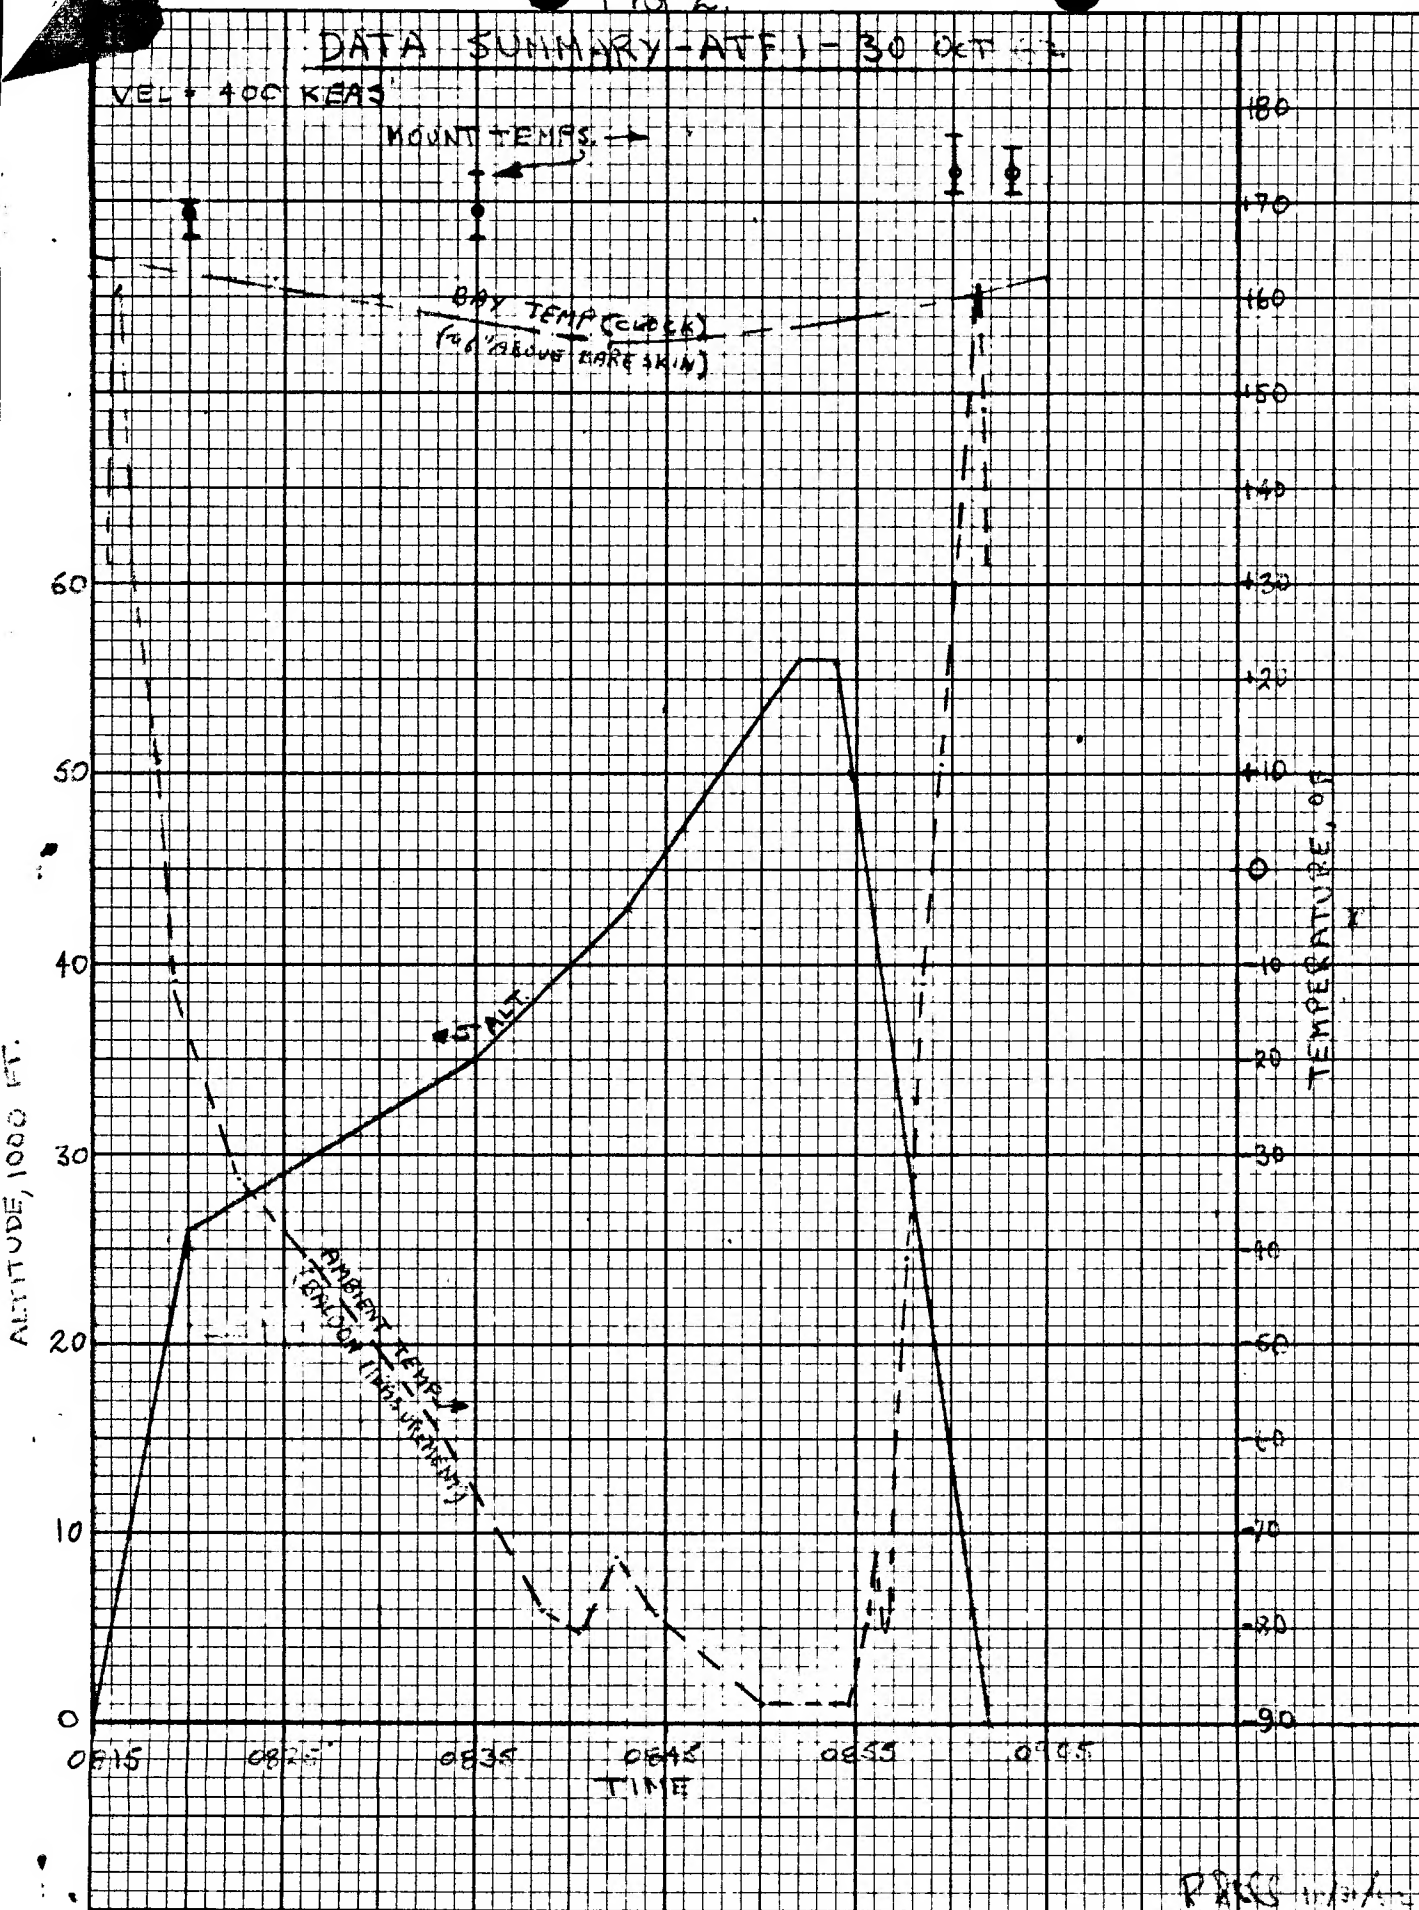
FIG 2

As regards the test data itself, one recorder did not function for ATF 1 due to the accidental breakage of a wire during hatch installation. Therefore, glass temperatures and vibration data were not obtained for this test. For ATF 3, the vehicle operator failed to report the times at which he actuated the recording equipment and although the data is presented in Figure 4, the times at which these data were obtained is unknown.

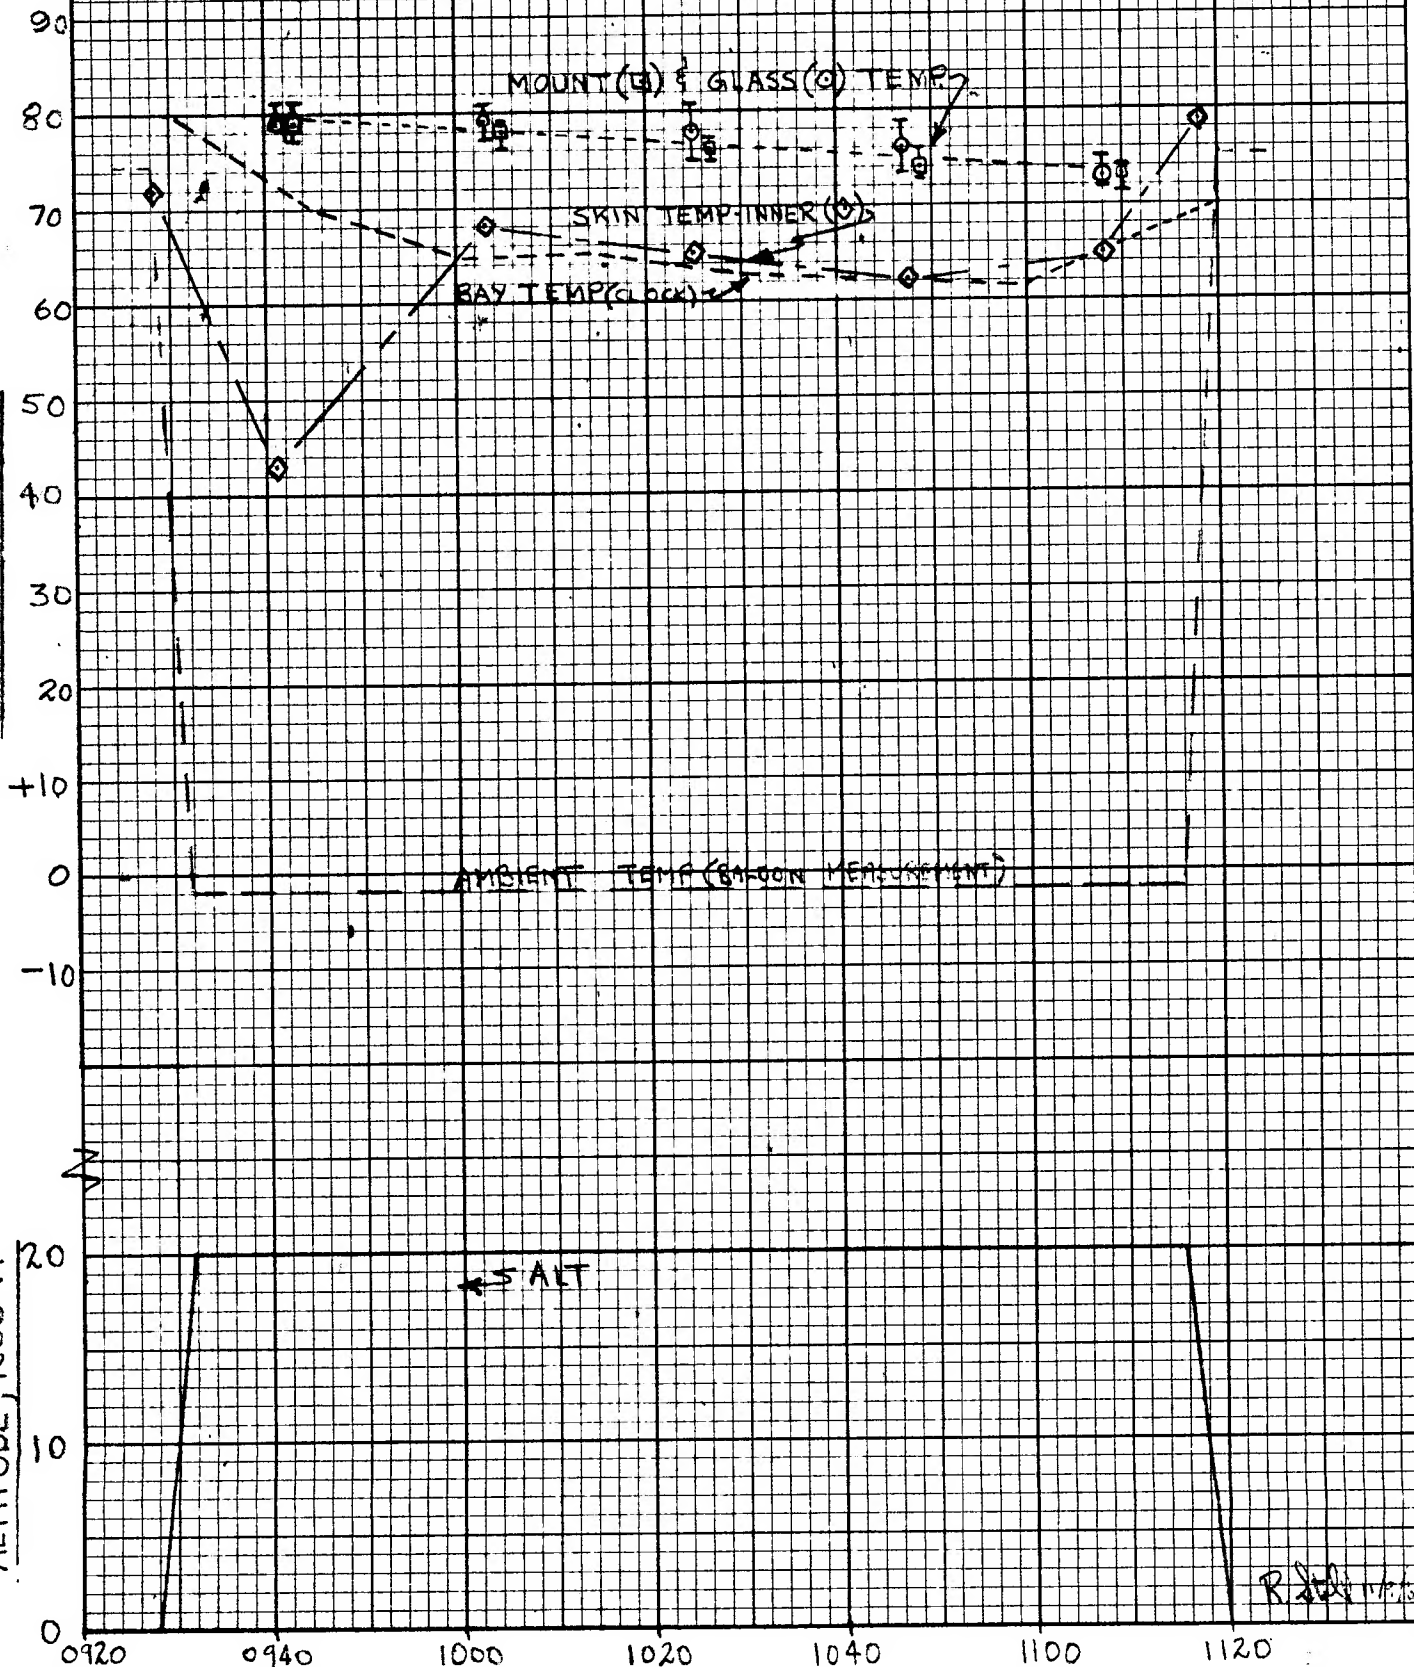
FIG 3

As an example, consider the data of ATF 2 (Figure 3). At approximately 1110 hrs., mount and glass temperatures were 73°F and bay temperature was 78°F. Calculation of expected skin temperature yields a value of 68°F which is almost identical to the measured skin temperature of 65°F. However, the total differential being but 8°F, an error of only 2°F would result in a 25% error in calculation. Moreover, the calculated effect of the total possible change in mount temperature which could result from our changing mount spacers is but 6°F as opposed to an expected 60°F for design conditions.

For ATF2(Figure 3) all equipment functioned properly; and flight parameters (constant altitude and speed, 2 hour duration) were the best of the three flights for approaching steady state conditions. It is felt, therefore, that the data of this test is the most useful as regards thermal characteristics. Figure 3 shows that measured mount and glass average temperatures are within 2°F of each other, and that the maximum spread is  $\pm 3^\circ\text{F}$  which is well within estimated accuracy limits of  $\pm 5^\circ\text{F}$ . Calculated overall heat transfer is of the order of 5 BTU/ft<sup>2</sup>-HR and calculated inner skin temperature is 68°F versus measured values of 62°F-65°F during the latter portion of the mission. At a mach no. of 0.85 the temperature ratio of total temperature to ambient temperature is 1.142. Assuming outer skin (and glass) temperature of 60°F, the calculated ram rise recovery is 95% which seems rather high. Vehicle People estimate ram rise recovery at approximately 80% based on skin temperature measurements at the upper hatch. This would yield an outer skin temperature for ATF 2 of 50°F.
